U.S ENVIRONMENTAL PROTECTION AGENCY
SUBAREA II FOURTH AVENUE AND GAMBELL STREET REMOVAL ACTION
INDOOR AIR QUALITY QUESTIONNAIRE AND BUILDING INVENTORY

Preparer's Name: Robert Whittier/Carl Overpeck Date Prepared: 22-February-2014

Property address: EA Block 26A Lot 5; 720 East 3rd Avenue, Anchorage, AK. 99515

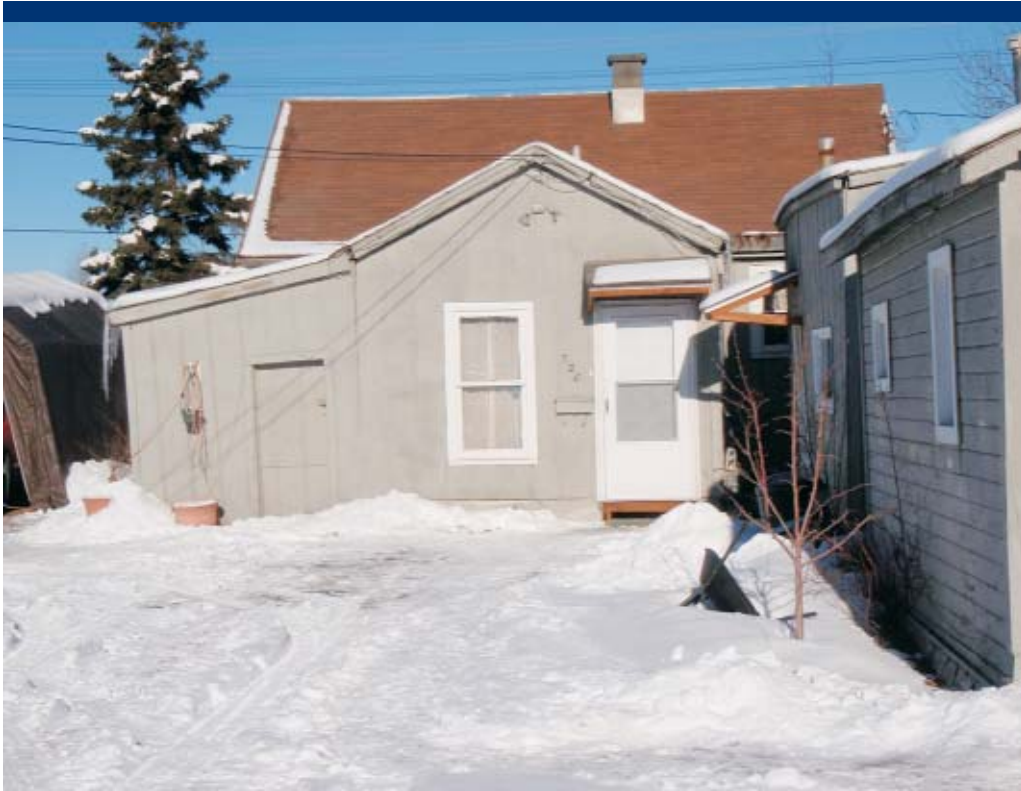
Photo 1 720 East 3rd Avenue (Residence).

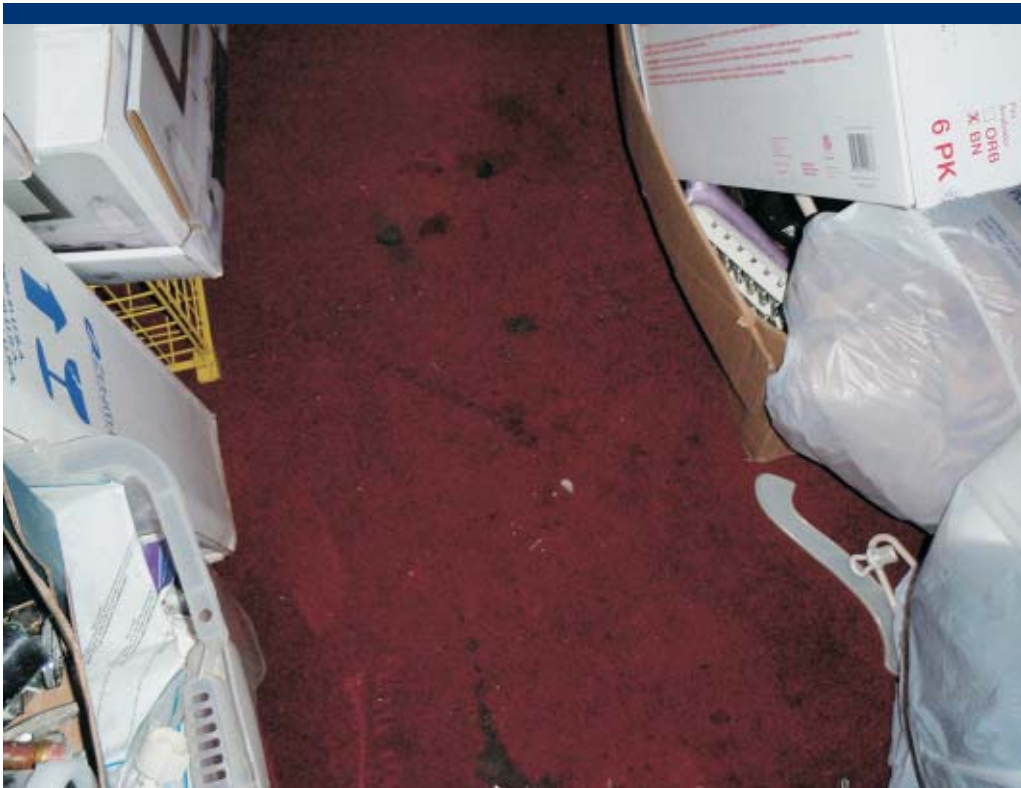
Photo 2 Common area "pathway" below stairwell.

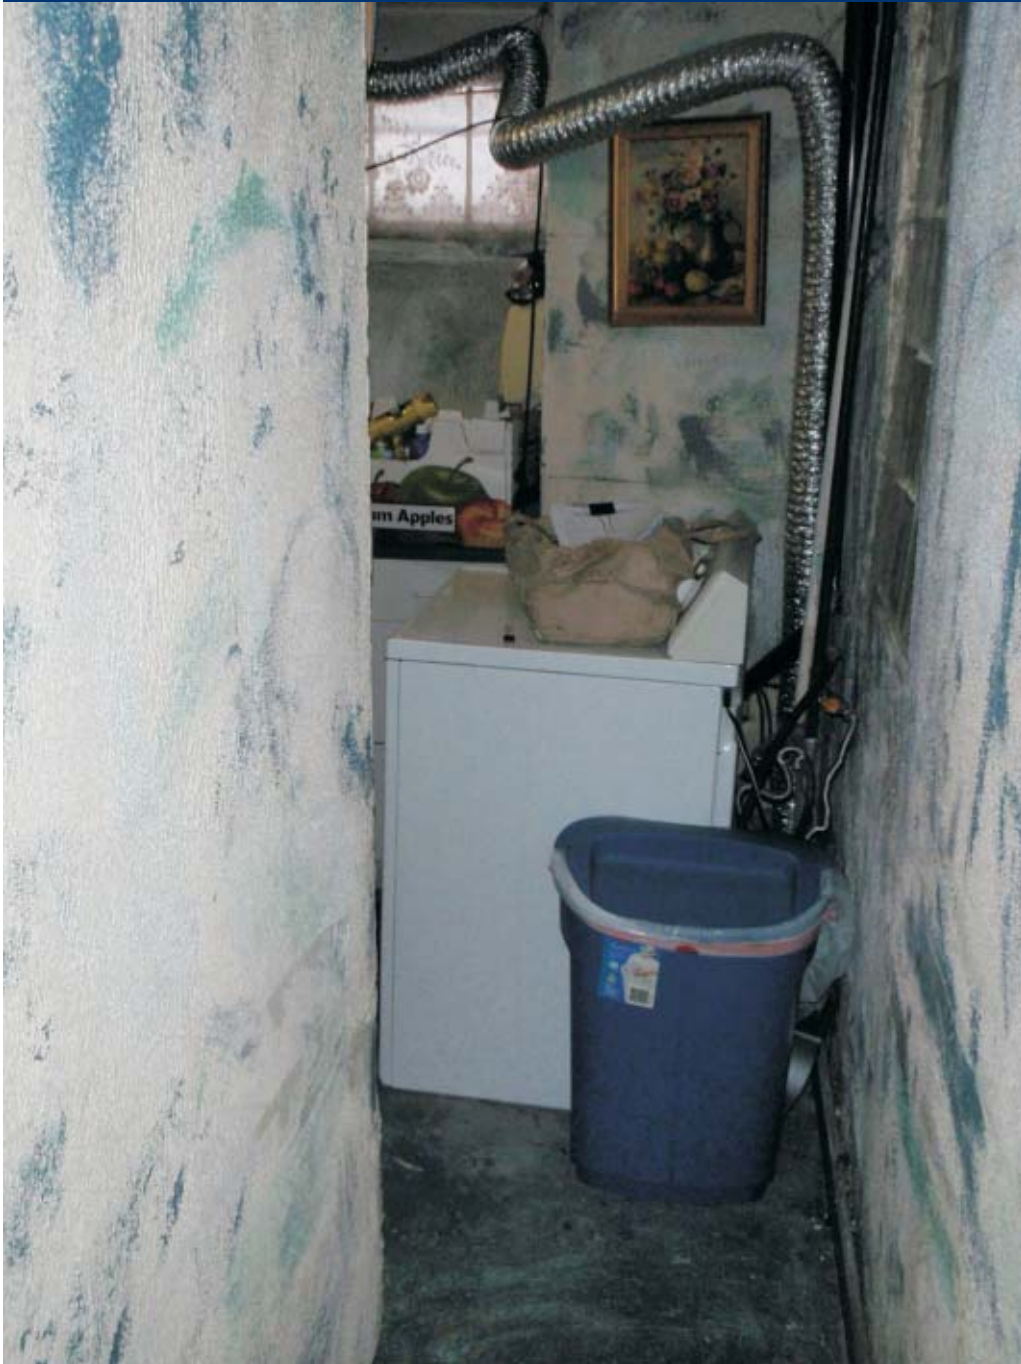
Photo 4 Hallway to utility room, and dryer.

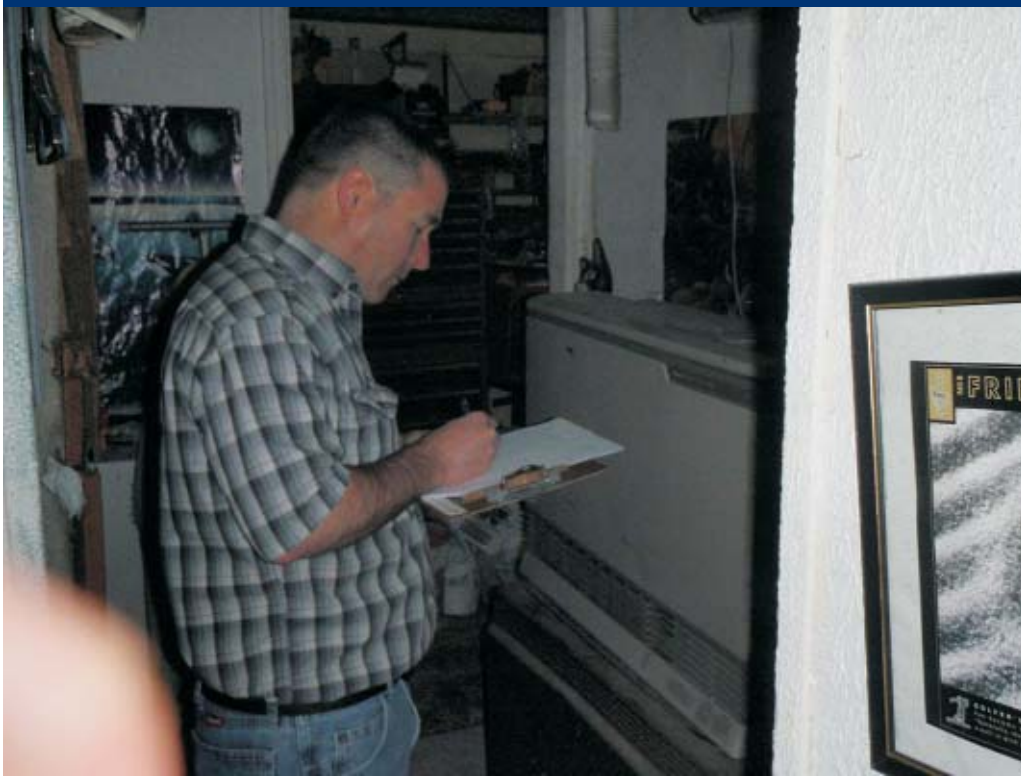
Photo 5 OSC Whittier, space heater, tool room in rear.

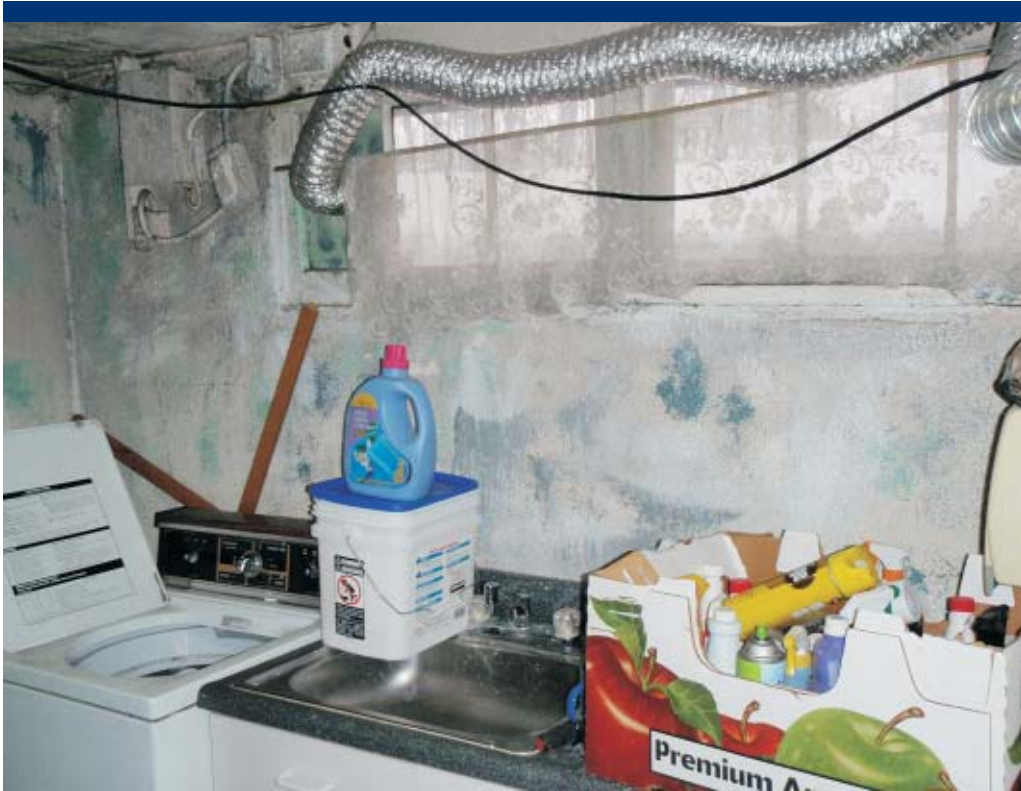
1. Location & Estimated Quantity: Sprayed on popcorn ceiling
2. General Condition: ☐ Good ☒ Fair ☐ Poor
3. Other Comments: _____

Photo 7 Washer and sink in utility room. Note electrical top right & popcorn paint wall coating.

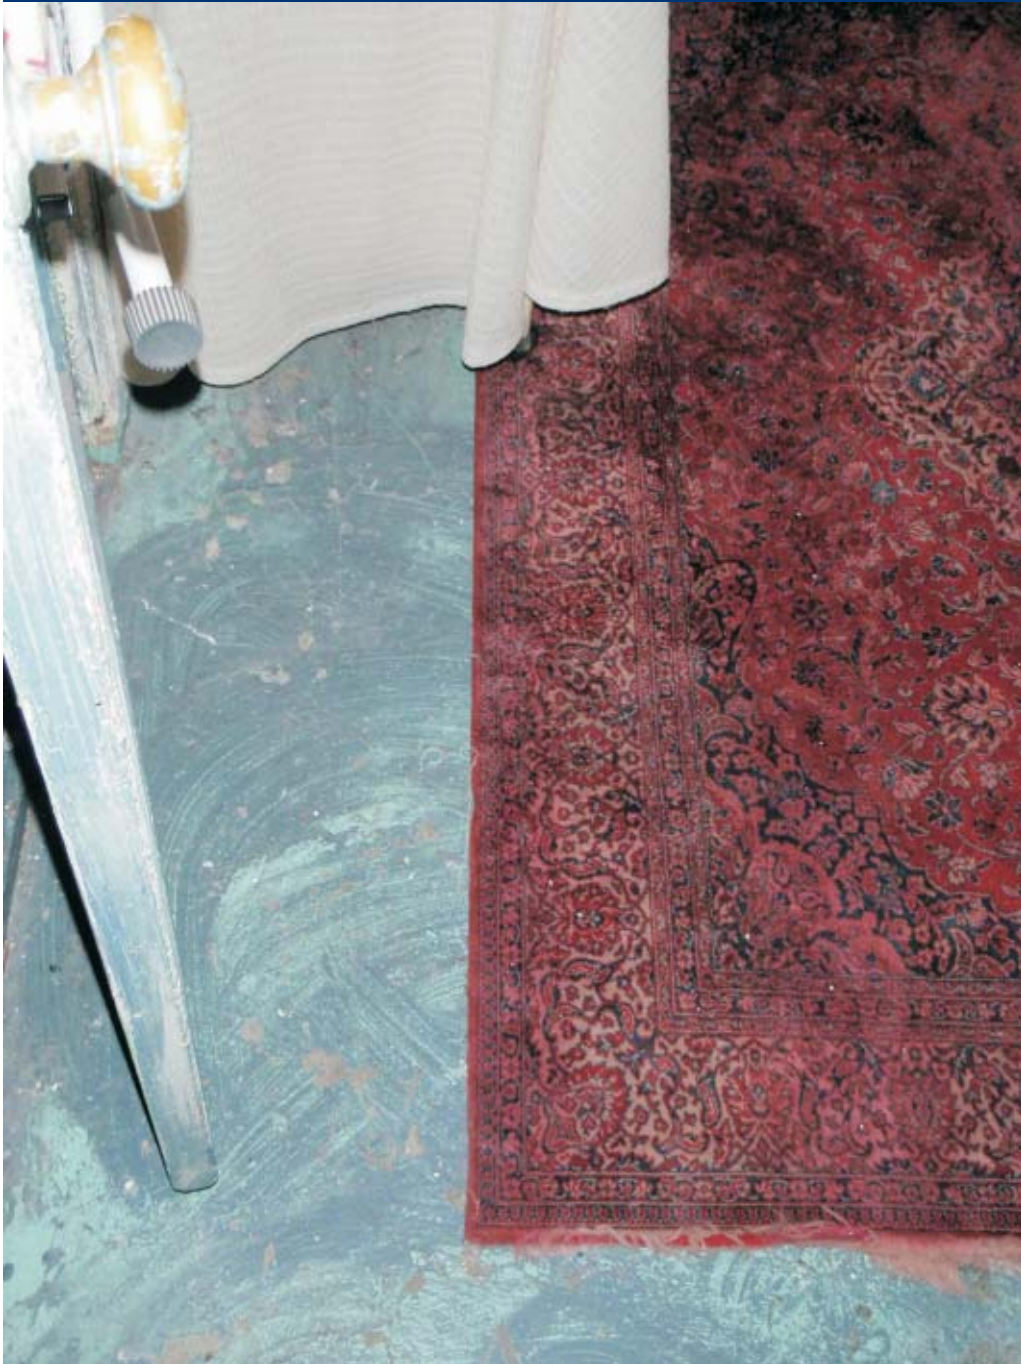
Photo 8 Painted concrete floor in utility room with throw rug.

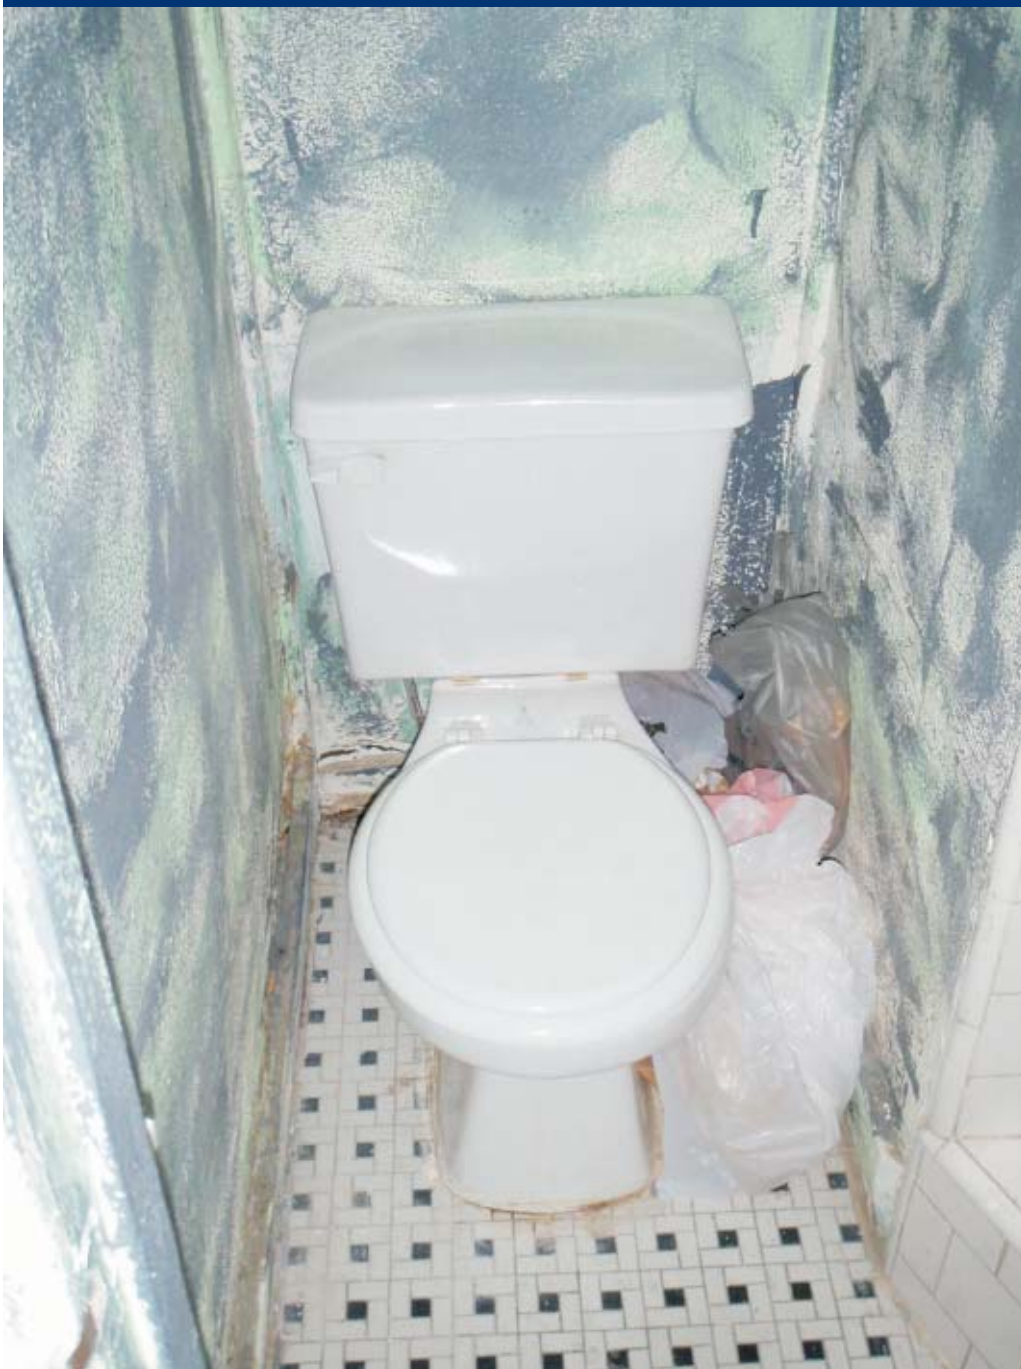
Photo 9 Toilet.

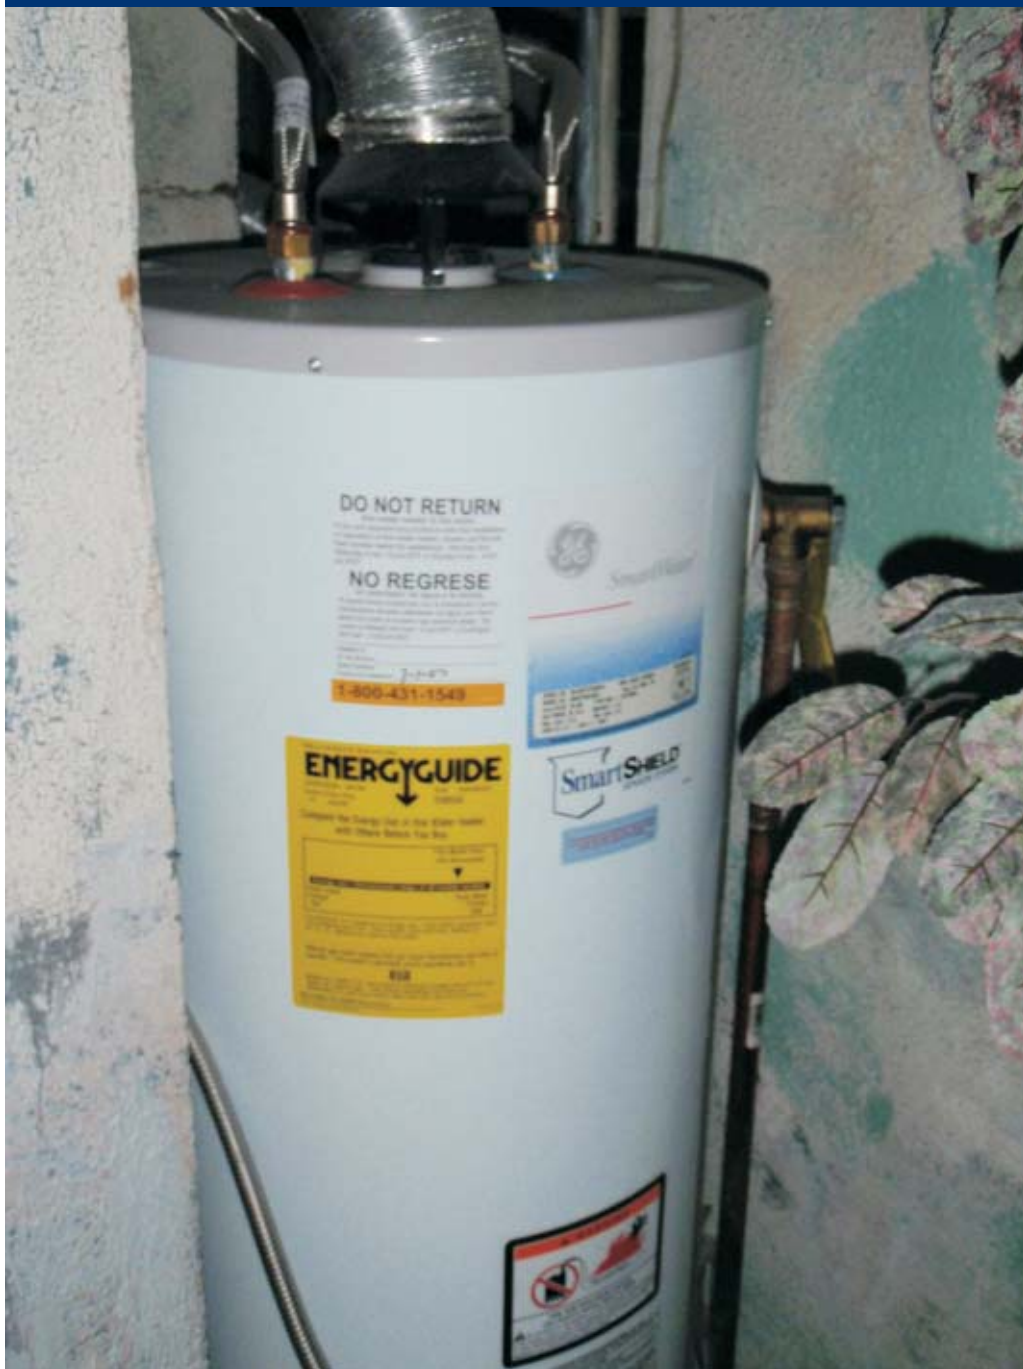
Photo 11 Water heater in utility room.

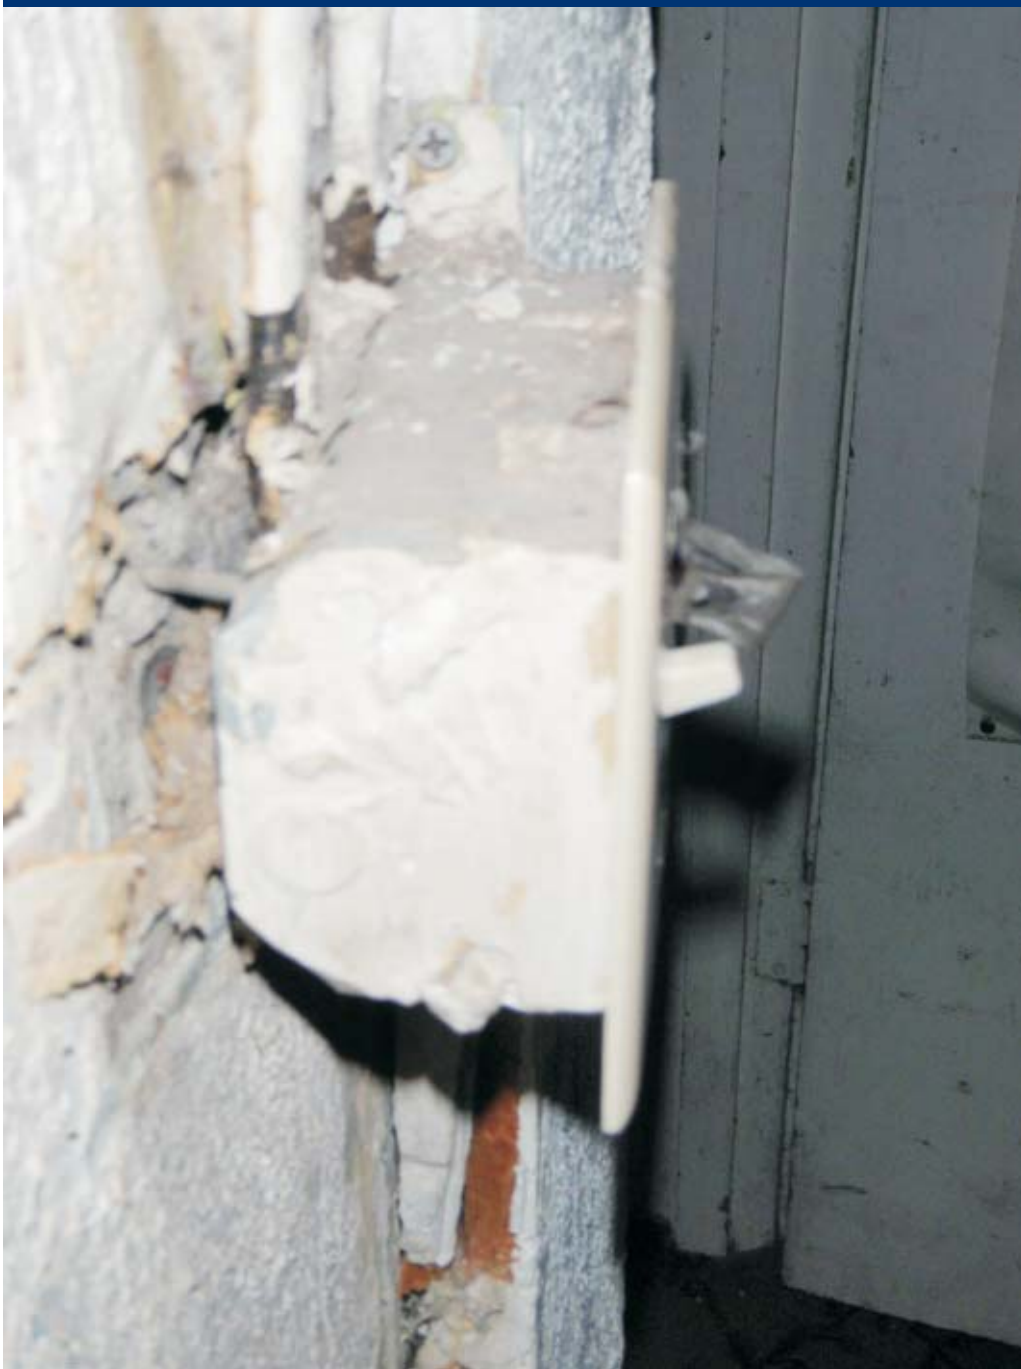
If yes, describe: Crawl space, electrical wiring, and personal property storage.

Photo 12 Miscellaneous derelict electrical.

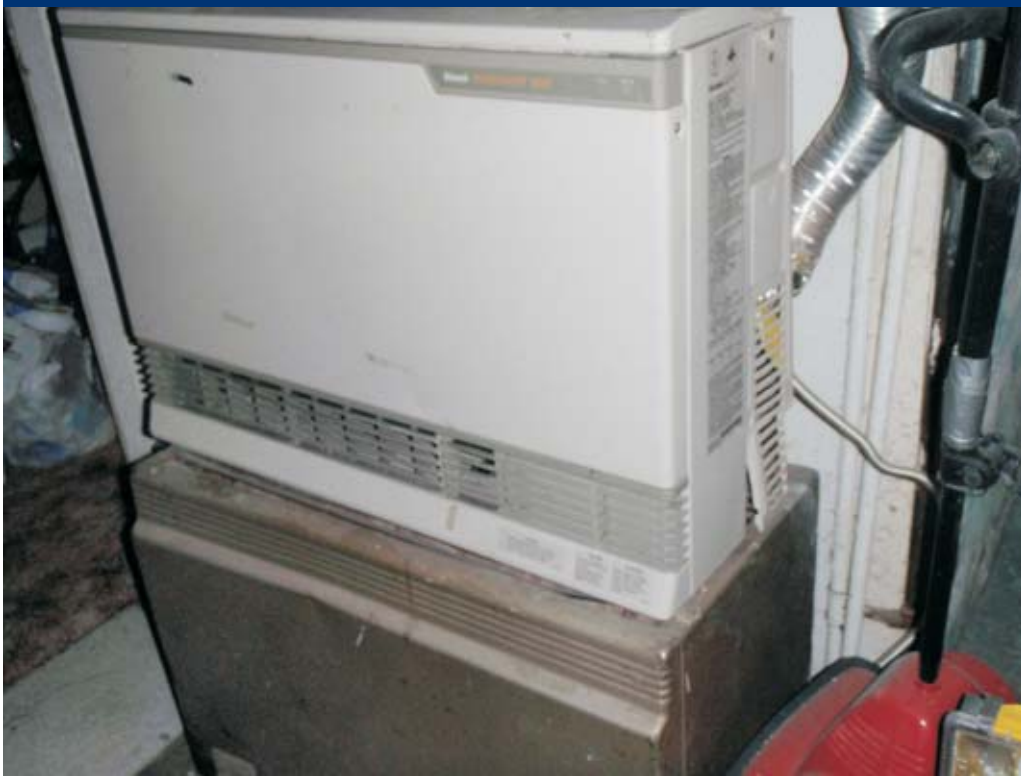
Photo 13 Space heater.

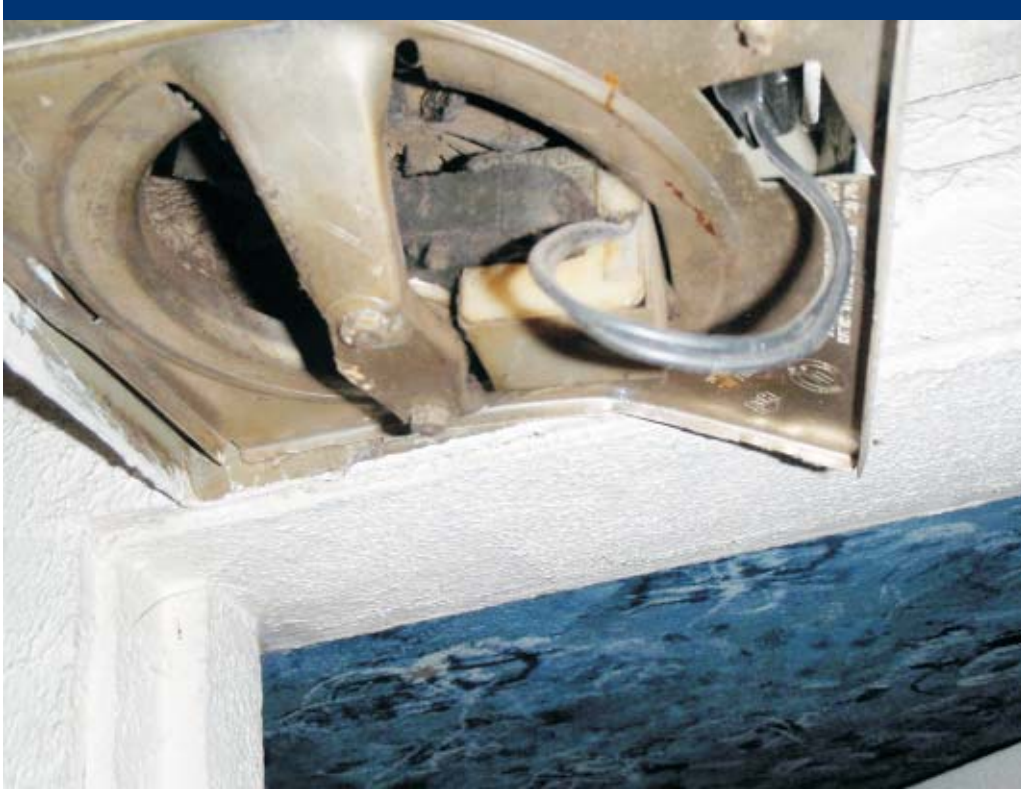
Photo 20 Miscellaneous derelict electrical.

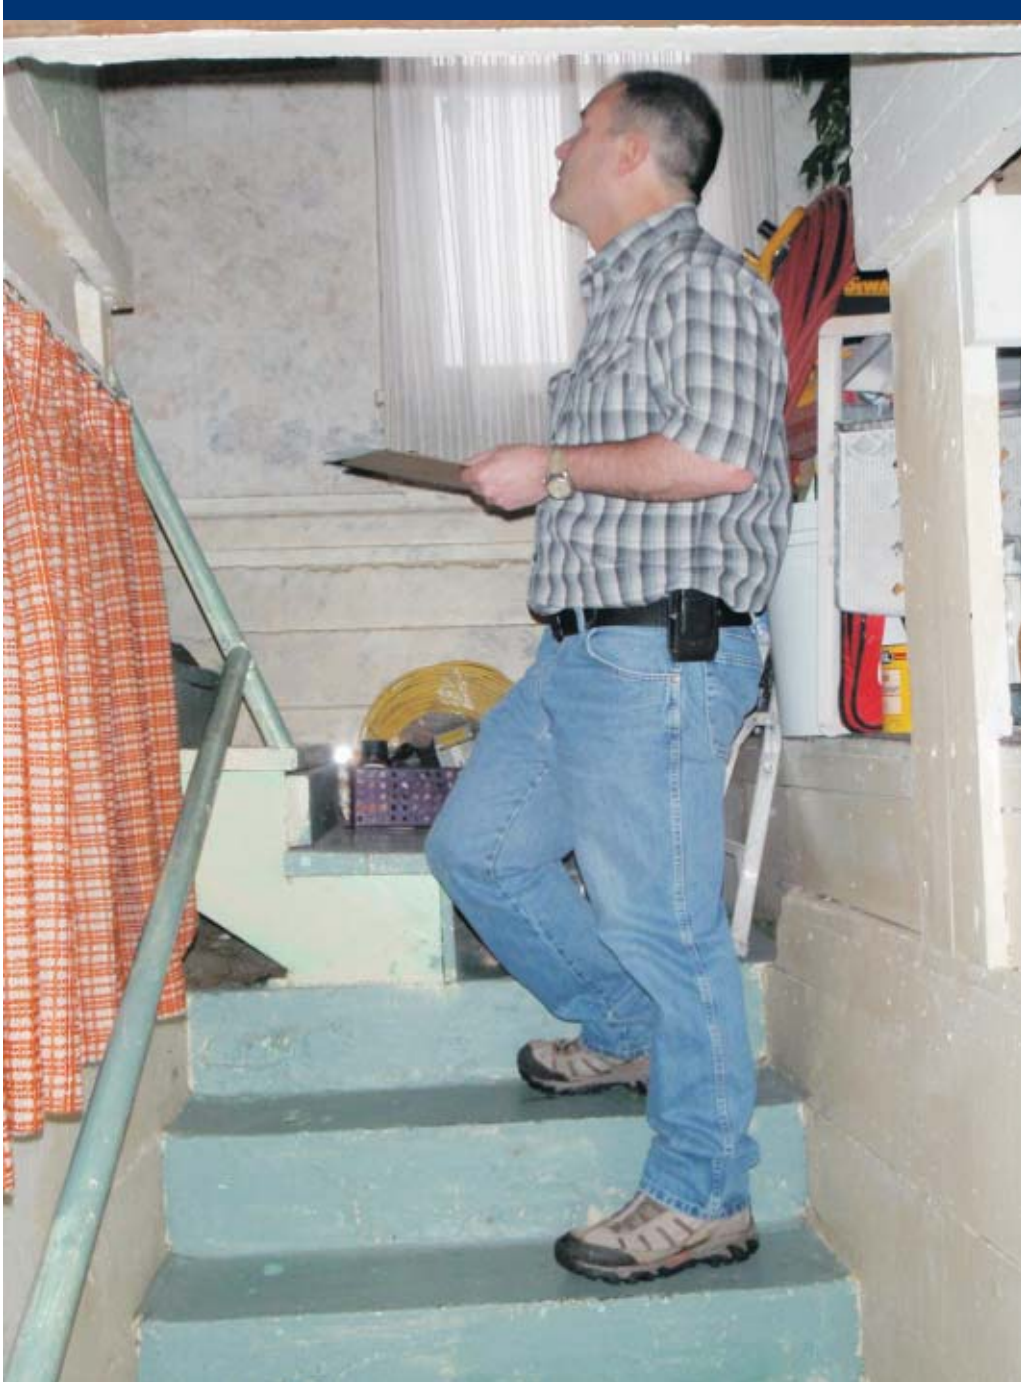
Photo 21 OSC Whittier on stairwell.

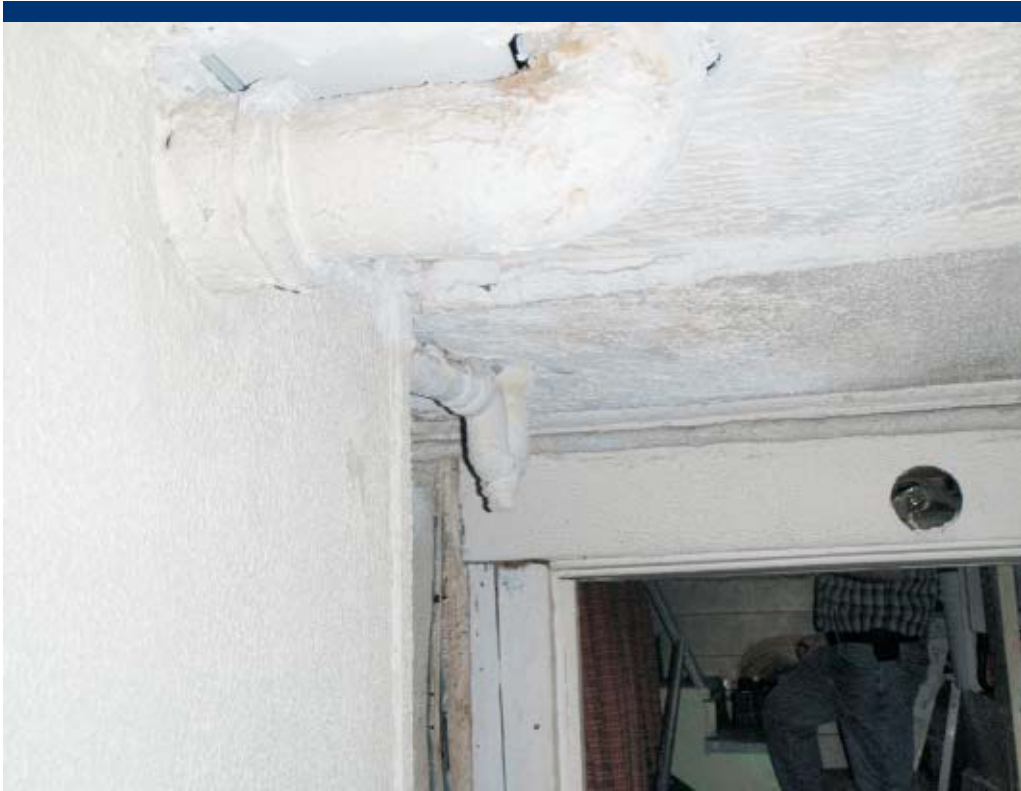
Photo 22 Sewer pipe from above. Note popcorn paint.

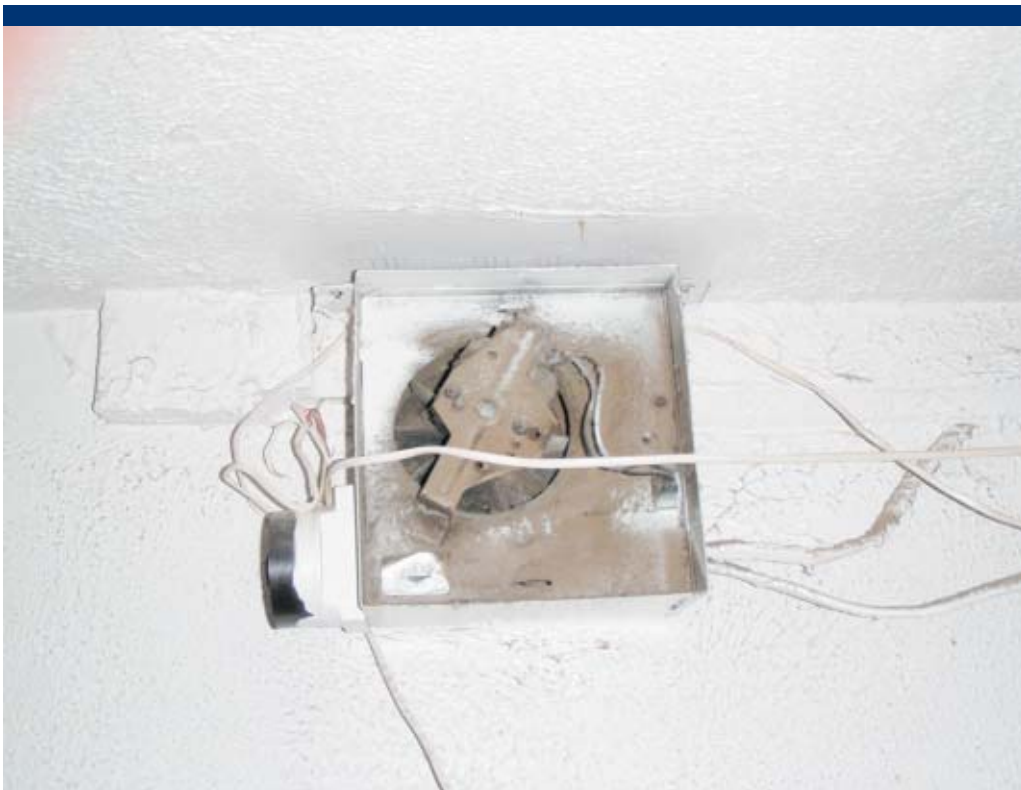
Photo 23 Miscellaneous derelict electrical.

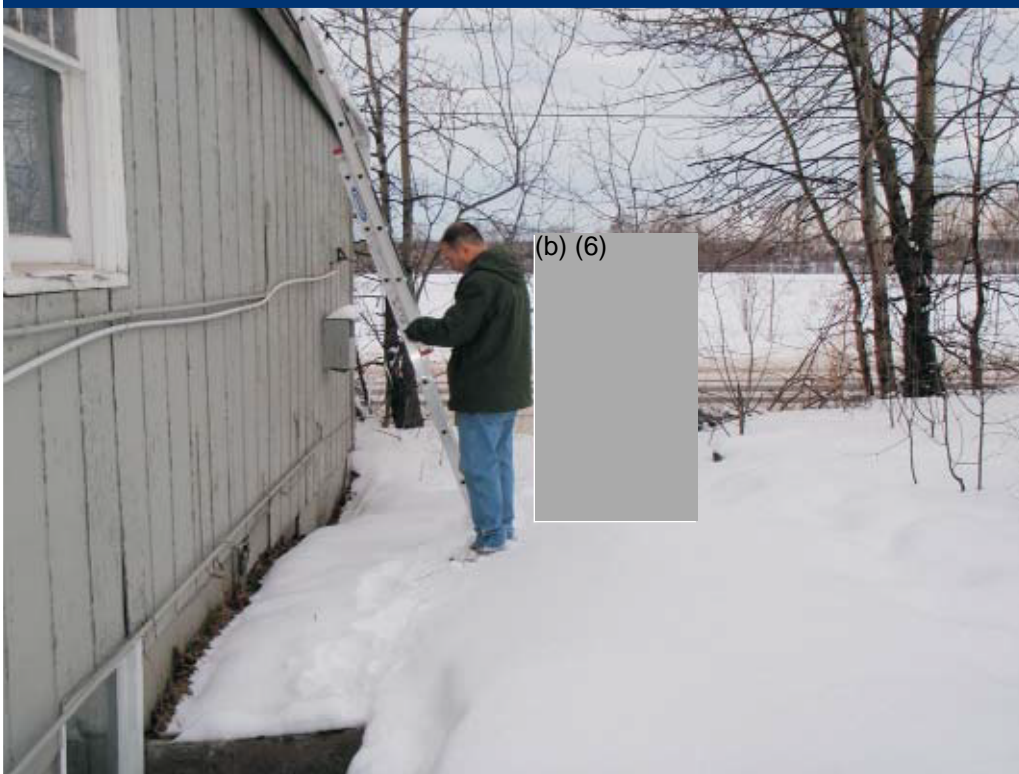
Photo 24 OSC Whittier & owner (b) (6) viewing location of master bedroom addition and crawl space external access point.

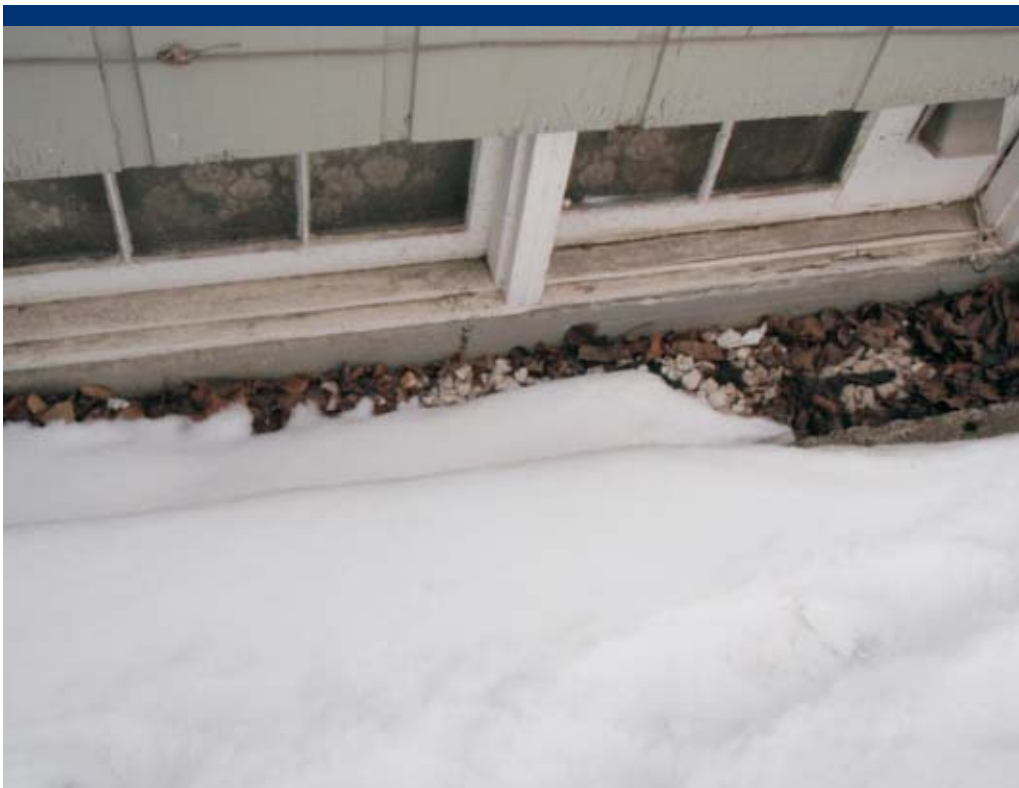
Photo 25 Utility room windows.

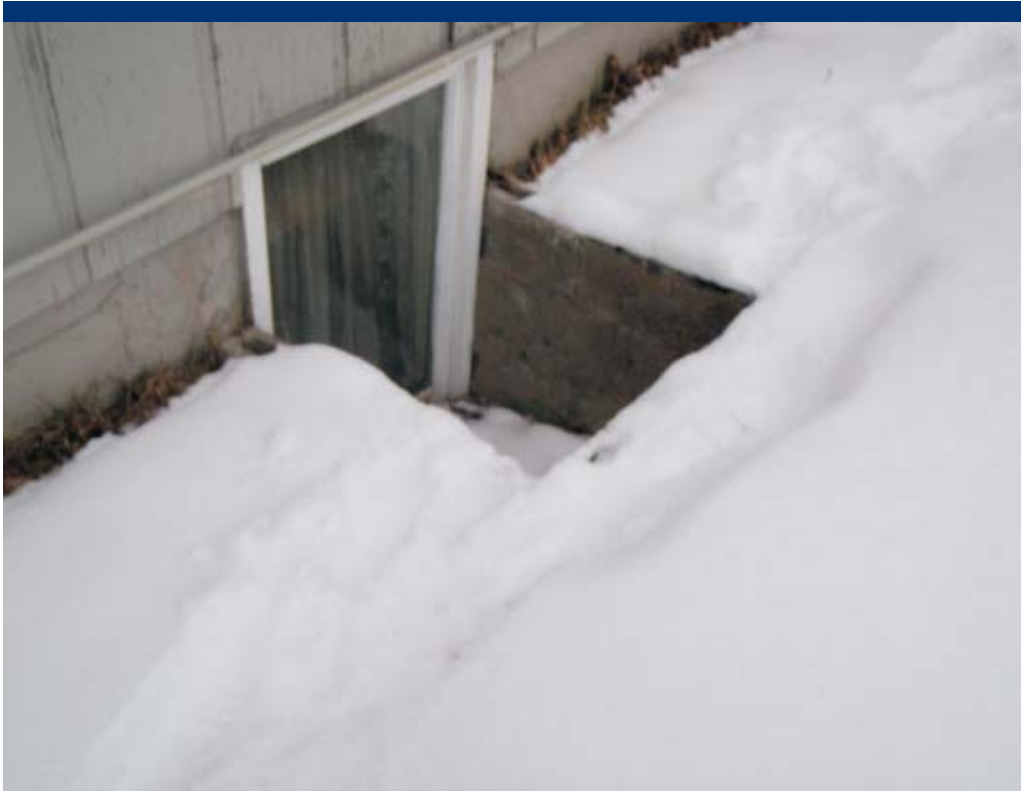
Photo 26 Tool room window.
